Service Bulletin AGAUS 02/2010

Rotor Blade Cracking

MANDATORY

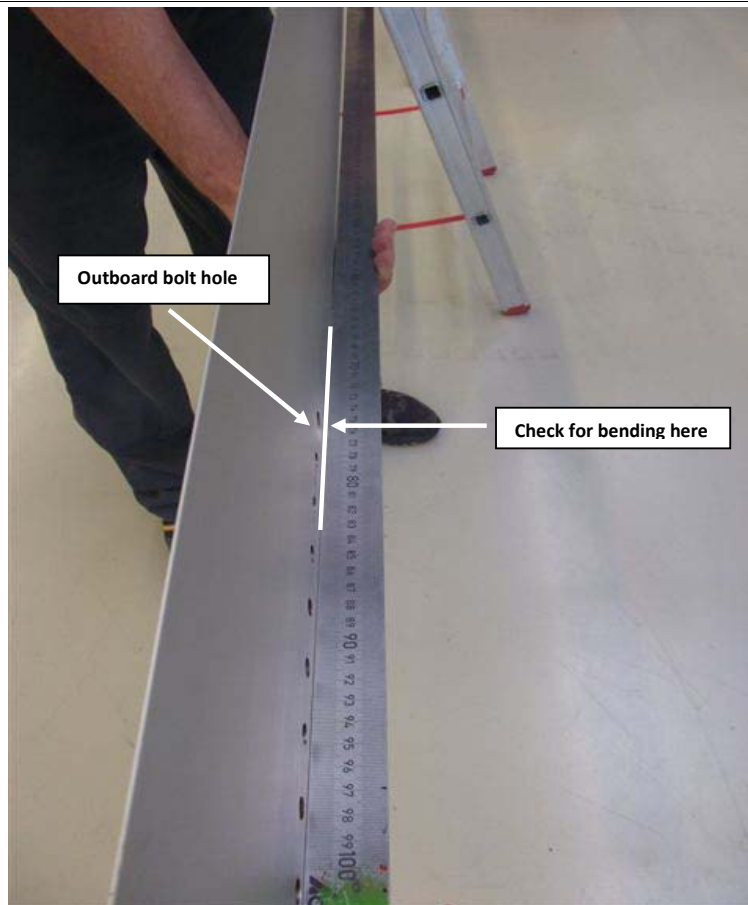
3.2	Instructions W – WARNING C - CAUTION	<ol style="list-style-type: none"> 1. Remove the rotor assembly from the aircraft and disassemble the rotor blades from the hub. Do not remove or adjust any other nuts/bolts on the hub bar assembly. 2. Ensure that the location of the side spacers in relation to the hub bar and the rotor head are marked for refitment, to maintain rotor balance. 3. Lay the blades with their bottom uppermost on trestles ensuring that no undue distortion is evident. 4. Clean carefully and degrease the inspection area. 5. Raise each blade on one edge without deforming the blade and lay the straight edge along the centreline of the bolt holes (see photo). Check for bend around the outboard hole. No bend is permitted.

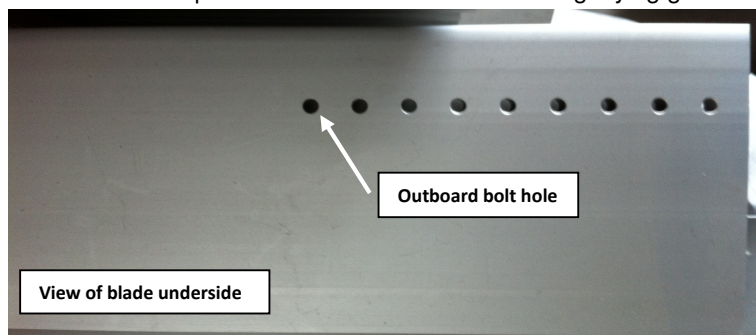
6. Carefully visually inspect the area of the outboard bolt hole on **both** the underside and top-side of the rotor blade with a magnifying glass.

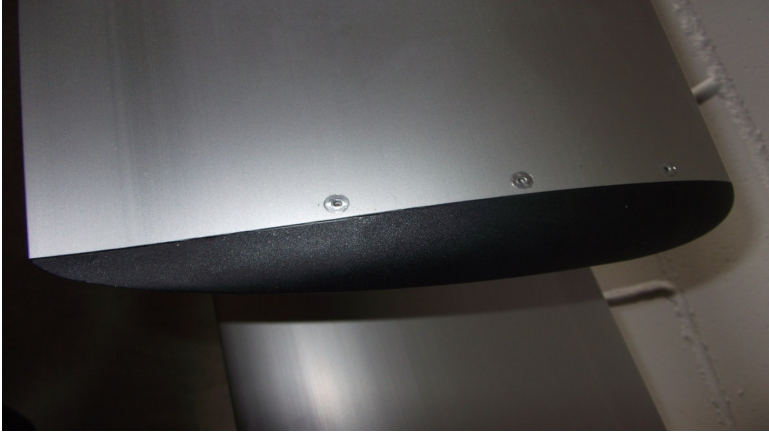
<p>On AutoGyro blades (rounded outer end cap) any crack is likely to be across the bolt hole itself.</p>

<p>On Aircraft blades (flat outer end cap) any crack is likely to be approximately 10mm outboard of the hole, or at the hole.</p> <p>Obviously, no cracks are permitted in any area.</p> <p>C - CAUTION</p> <p>7. After inspection, and assuming no fault is found, reassemble the rotors.</p> <p>The rotor blades, spacer extrusion and hub are individually numbered to define the installation direction. By matching these numbers, fit the spacer extrusion to the blades and then fit the blades into the hub. Insert the 9 bolts through the hub and blade assembly from the top then fit the washer and new M8 nyloc nut to the bolt on the lower surface.</p> <p>DO NOT hammer the bolts home! Normally no tracking adjustment is required, simply tighten the rotor blade attach bolts to 20Nm.</p> <p>To check the tracking, use a taut string line between the rear outside corners of the blade ends. If required, tracking may be adjusted prior to tightening the nuts by tapping the blades by hand in the hub bar so that the string passes directly over the centre of the grease nipple in the centre block.</p> <p>When satisfactory, tighten all 18 nuts to 20Nm</p> <p>Re-fit the rotor assembly to the aircraft ensuring that the location of the side spacers in relation to the hub bar and the rotor head is correct. Use a new split pin in the teeter bolt nut. Ensure that the teeter bolt is only tightened finger-tight.</p> <p>N - NOTE</p> <p>8. AutoGyro Australia require that the actual inspection is carried out and noted in the aircraft log book by the authorised person/s only.</p> <p>9. If after inspection, the rotor is cracked or considered defective contact AutoGyro Australia immediately. No further flight permitted.</p>
